Scoped Environmental Impact Study (sEIS)
Proposed Single Residential Development
The South Road, Wollaston Lake
Part Lot 23, Concession 5 & 6
Township of Wollaston, County of Hastings

Project #: 23-3326

February 2024

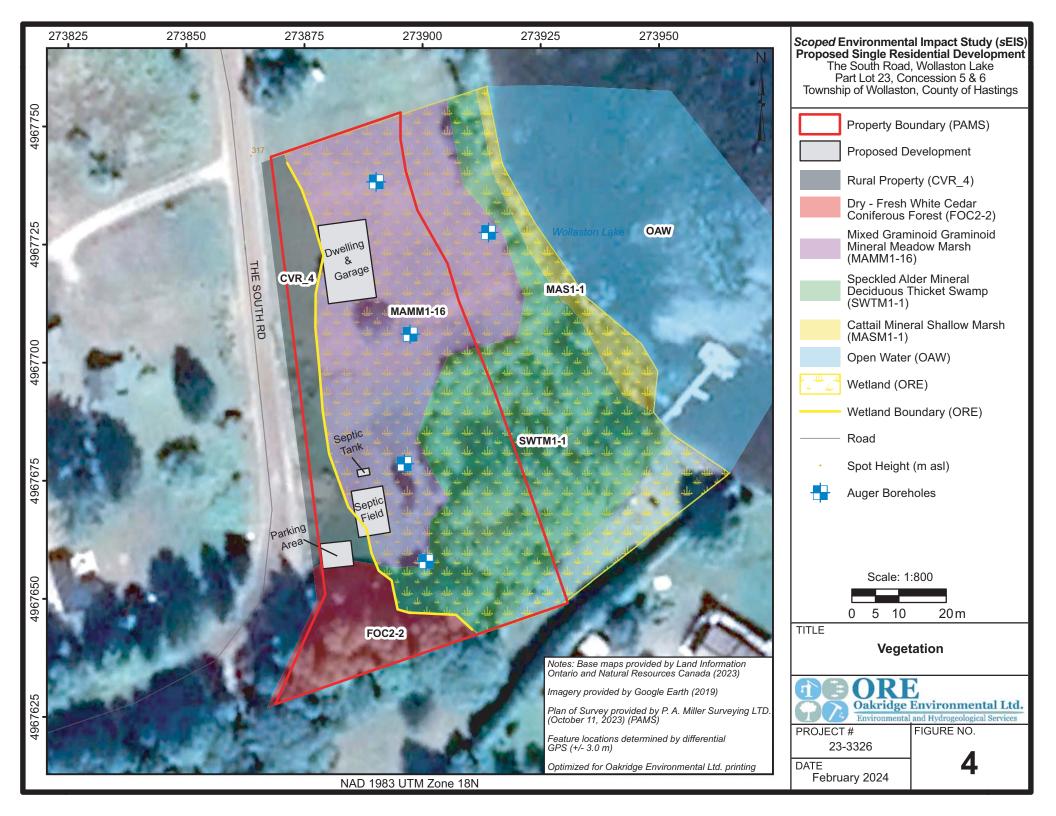
Figure 4 illustrates the distribution of the on-site vegetation communities, and the off-site aquatic community. These habitats and their associated vegetation and environmental sensitivities are characterized below.

The wetland boundary is illustrated on Figure 4.

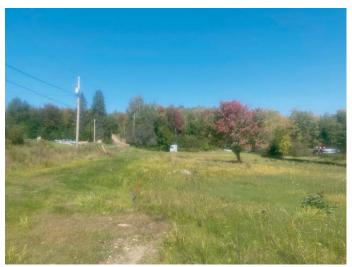
Photo A (Above): Taken looking north from the southern portion of the property. The South Road is located just west of the hydro line and elevated above the site. A single Freeman's Maple (reddish) occurs in the middle of the property. The property has been cut low over the years giving it a lawn-like appearance.

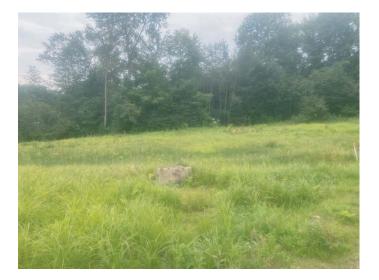
Photo C (Above): Taken looking southeast towards the southeast corner of the property. The majority of the understory in this area consists of Speckled Alder which is a wetland species. There are also poplar, birch, spruce, cedar and other tree species which can also occur in wetland habitats.

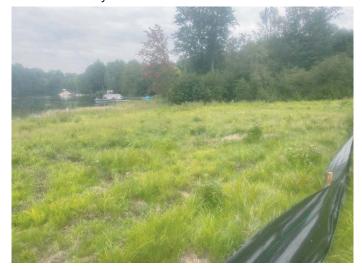
Photo D (Above): Taken looking southeast from the midsection of the property and closer to the waterfront. The property owner has installed some light-duty silt fence due to some grading that was completed behind the photographer. The shrub species along the tree-line is Speckled Alder, the wetland shrub mentioned in the previous photo (C). There is also Soft-stemmed Bulrush and cattail along the shoreline. Just beyond the fence in the foreground is an abundance of meadow marsh species, suggesting this wetland community occurs towards the base of the slope and continues up the entire on-site slope towards The South Road.

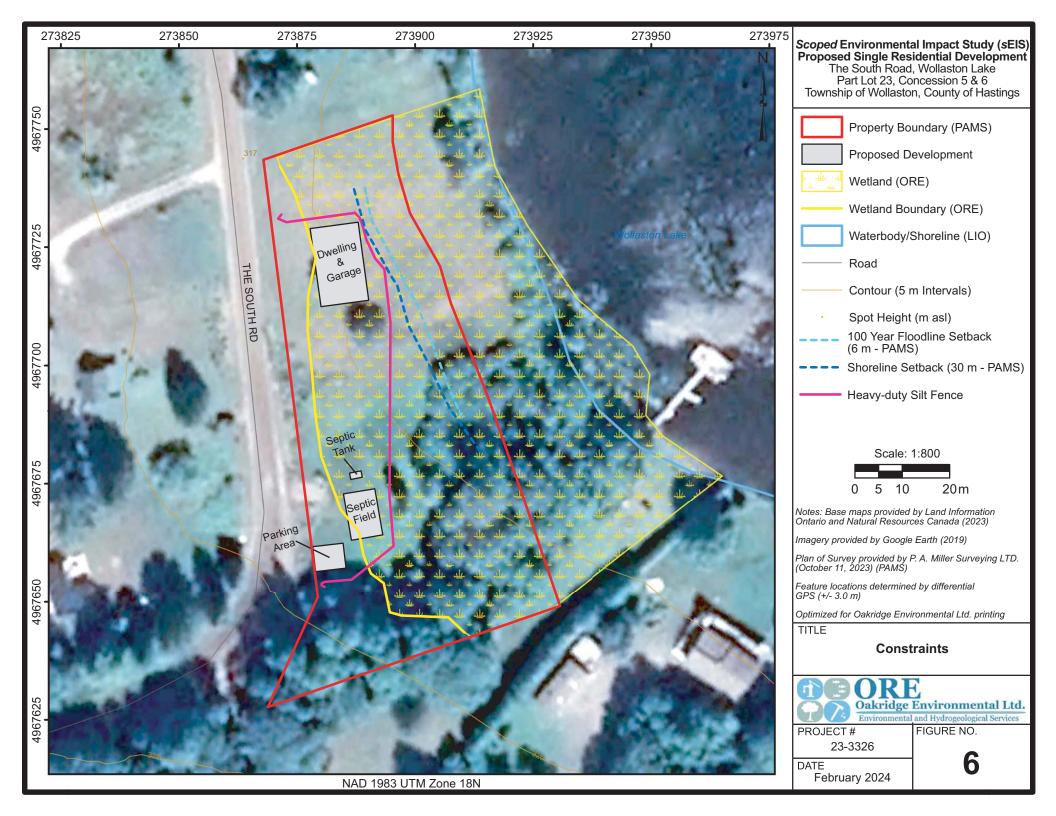
- To ensure the development does not advance any closer than necessary to Deer River/Wollaston Lake, the building envelope should be clearly demarcated on-site by installing a heavy-duty silt fence, as illustrated by Figure 6. This will prevent the construction crew from unnecessarily increasing the overall disturbance footprint towards the lakefront, especially during the use of heavy equipment. The heavy-duty silt fencing will ensure that any loose/unconsolidated materials in the fill materials will not migrate beyond this limit, thereby protecting the remaining wetland and Deer River/Wollaston Lake (considered the sensitive hydrological features on-site).

- As there is a potential for turtles to occur within Wollaston Lake during the growing season (e.g., Snapping Turtle), the heavy-duty silt fence will not only serve as a building envelope boundary, it will serve as a turtle exclusion fence, as recommended by the Ministry of Natural Resources and Forestry (MNRF). Light-duty fence is not considered an exclusion fence material, as large turtles such as Snapping Turtle could dig beneath the fence or potentially push the fence over.

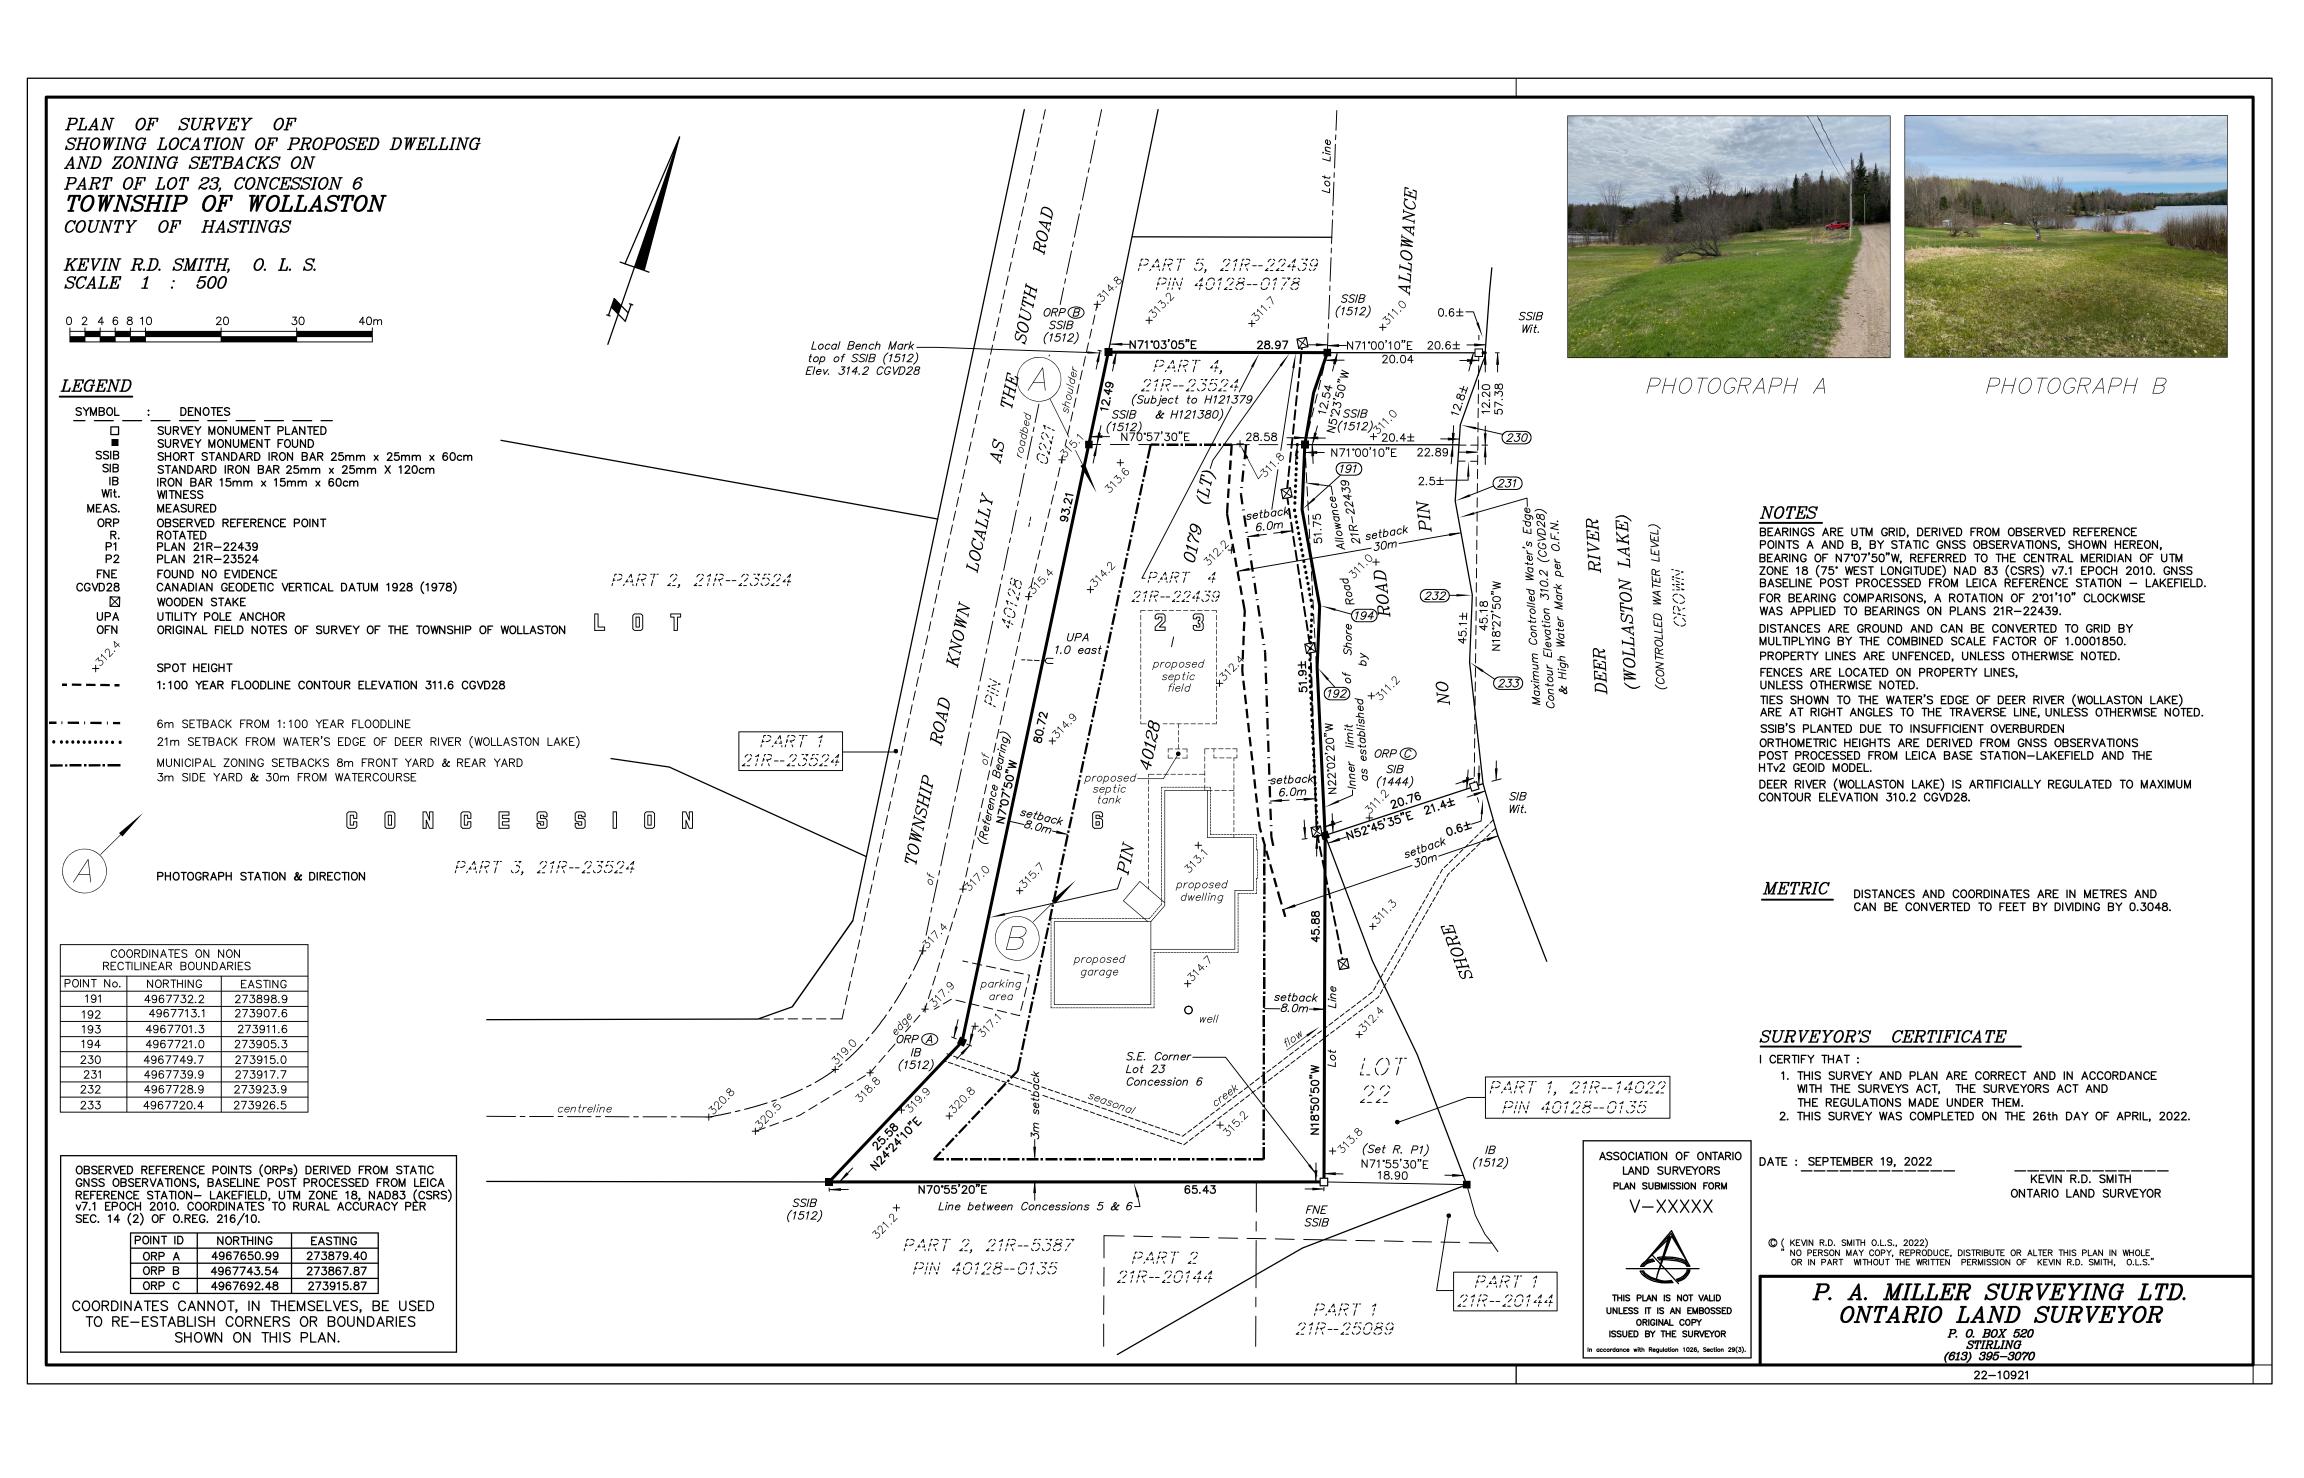
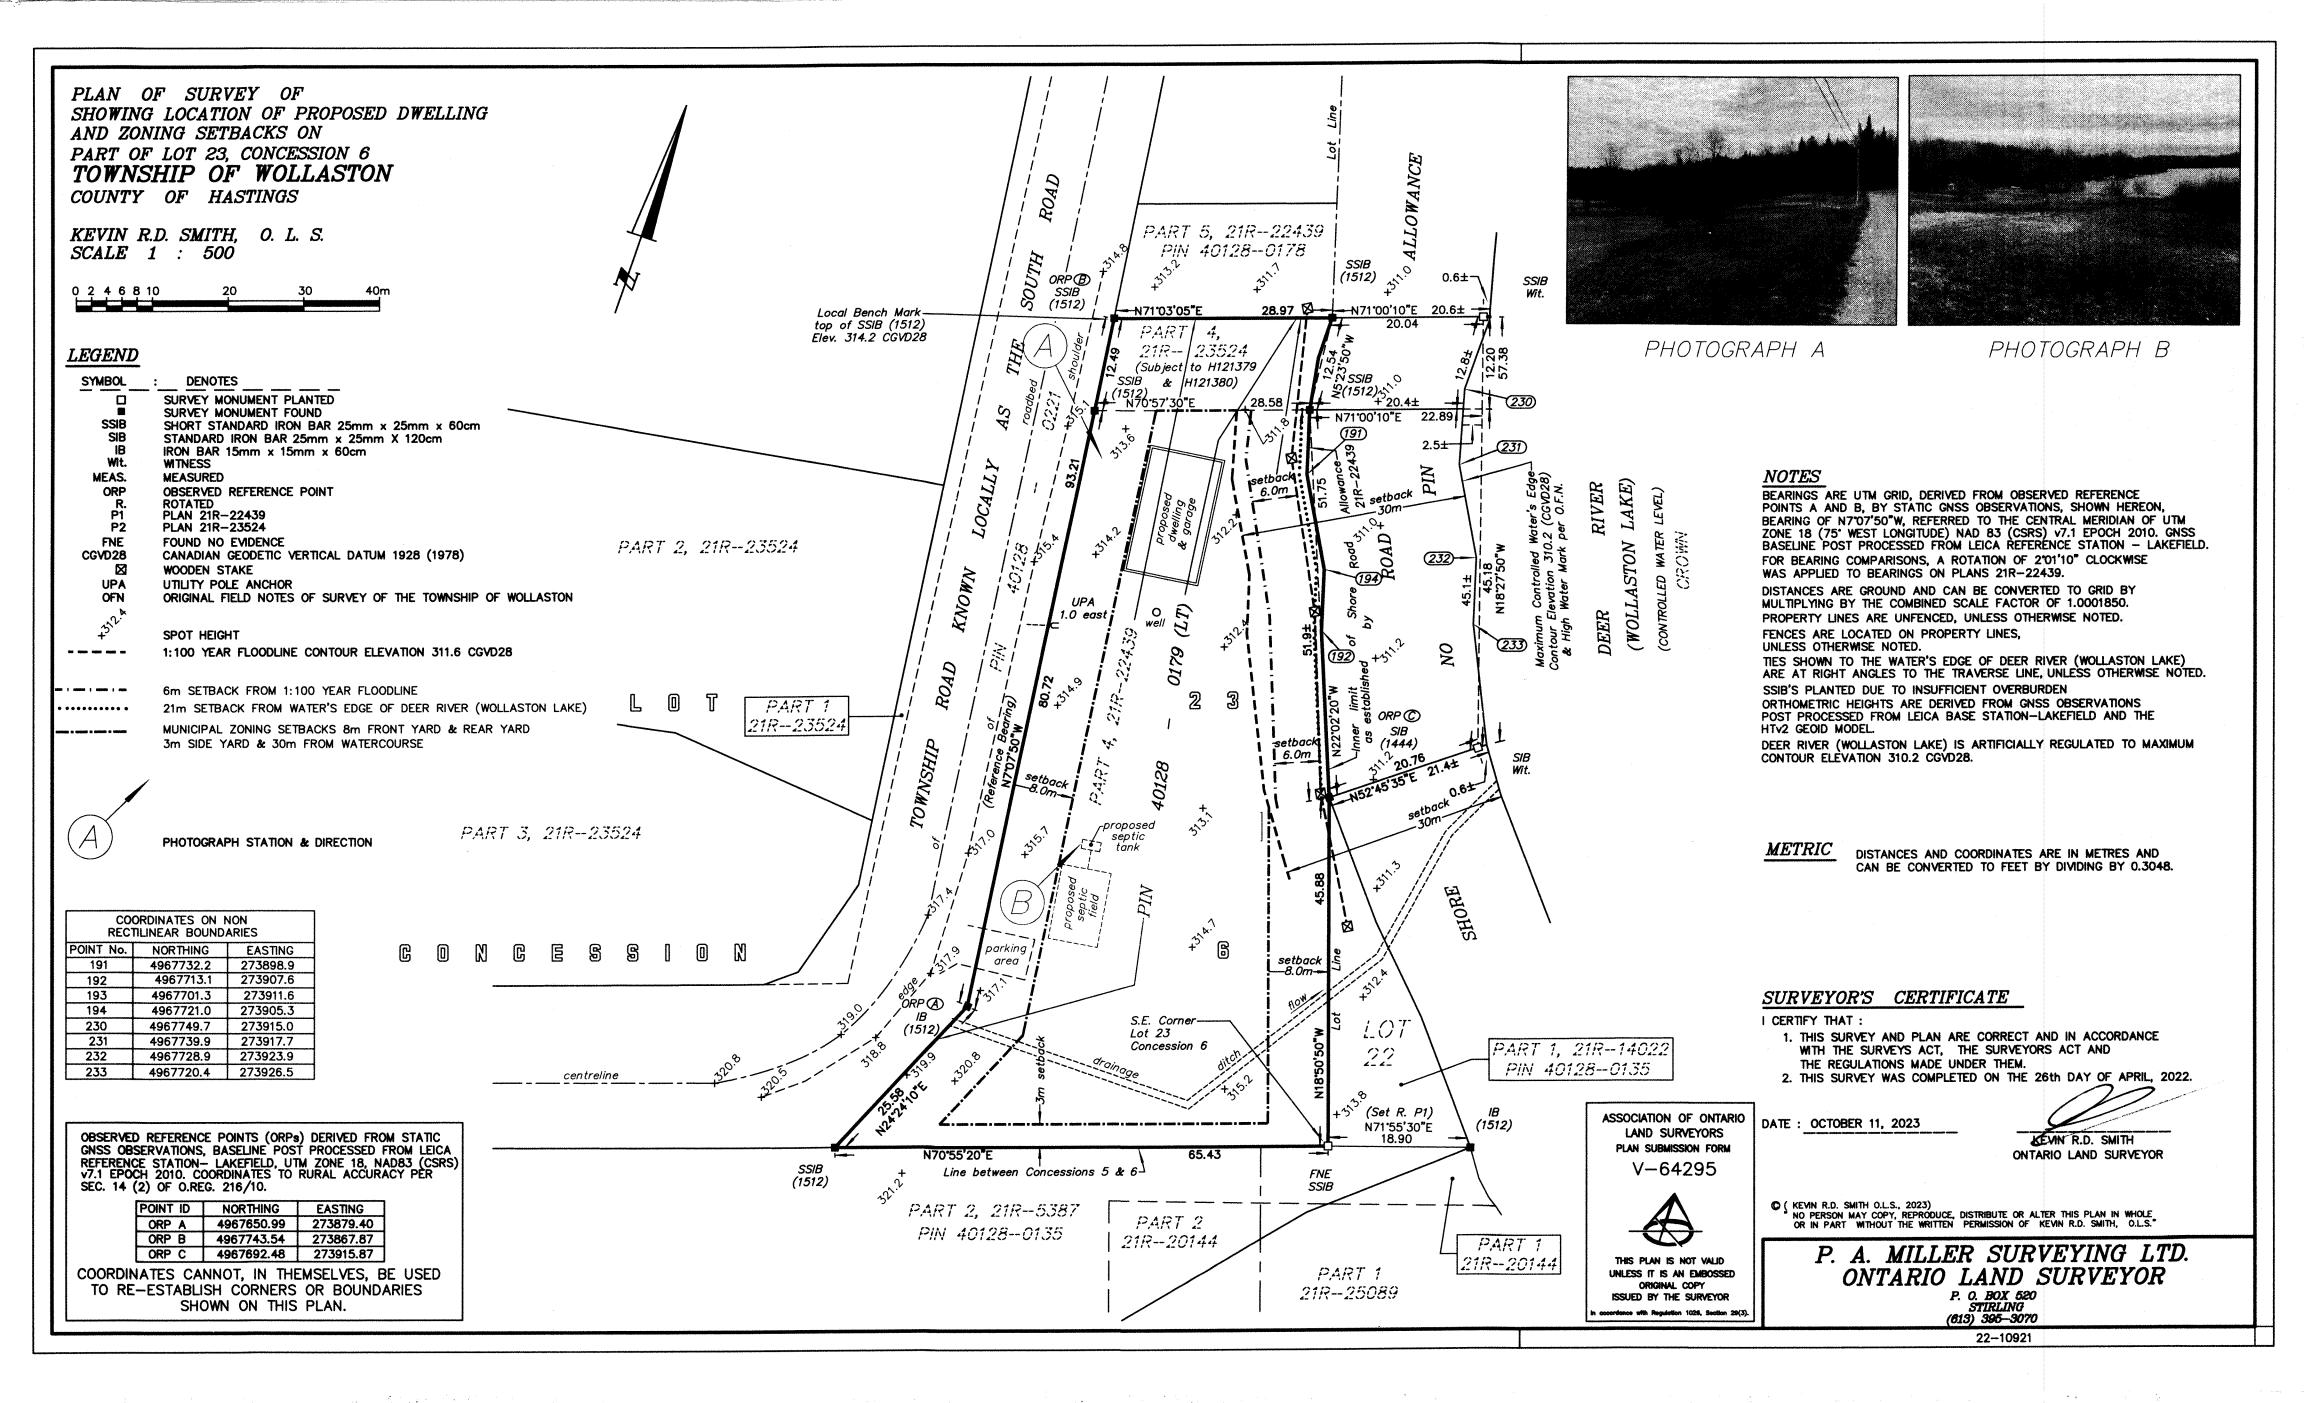
Proponent's Conceptual Development Plan

The proponent has provided a sketch identifying where the proposed dwelling/garage and septic system are to be located on the property, subject to approvals (Appendix A).
