85 Fire Route 19, Havelock ON

Control of Flooding Letter + Cut-Fill Calculations & Drawing

Jewell File No. 230-5387

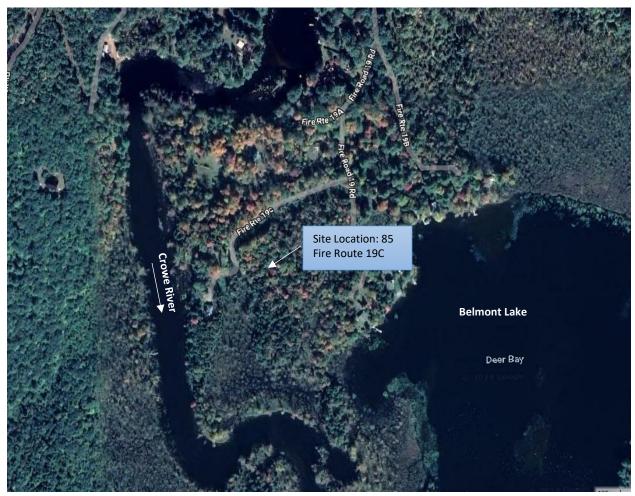
Site Location – 85 Fire Route 19C, Havelock

We have prepared this letter to summarize our calculations and recommendations to ensure the control of flooding is not affected by the proposed driveway at 85 Fire Route 19 located near the perimeter of Belmont Lake (see figure below). As part of this assessment, we completed the following:

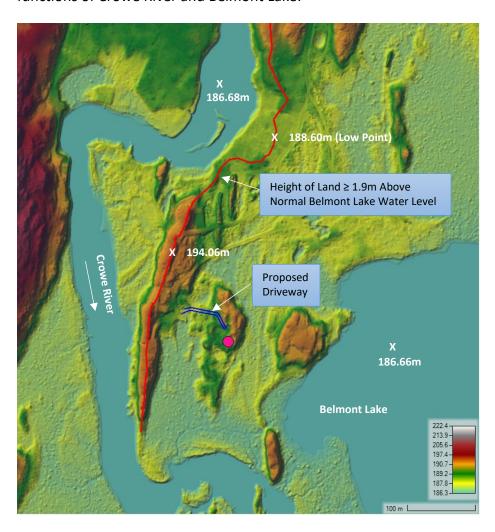
Schematic of Height of Land Separating Proposed Driveway from Crowe River Flow Path (Terrain Background)

It is obvious the proposed driveway is within an ineffective flow area since there is a minimum 1.9m height of land that separates the downstream branch of the Crowe River that inlets to Belmont Lake from the subject lot (see figure below). The subject lot is also located at the outside perimeter of the reservoir. As noted in the *Condition 1: Safe Access* discussion, the floodplain at the subject site is the result of the backwater imposed by the Belmont Dam, and velocities at the driveway in the regulatory event would be negligible (i.e. rounded to 0m/s).
